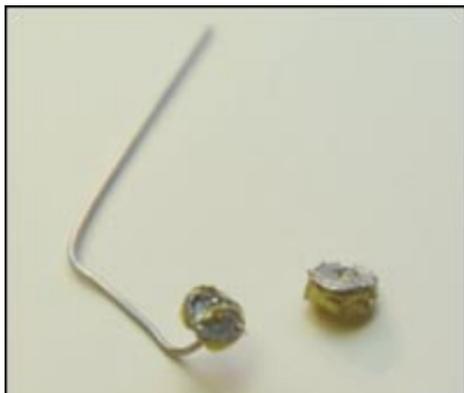
Reissue bumblebee leads
[Click for larger image](#)

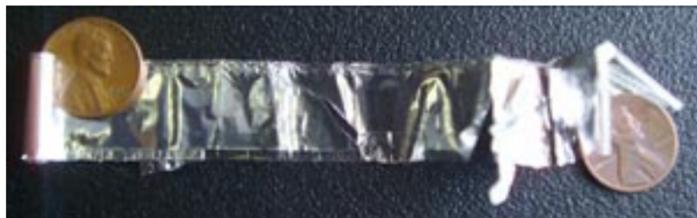
Reissue bumblebee foil
[Click for larger image](#)

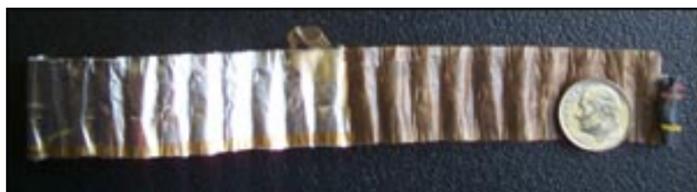
Original bumblebee foil
[Click for larger image](#)

When I started this project I contacted Sprague (the original manufacturer of Bumble bee capacitors), and got as much information from them as I could. Next I went to our purchasing records and searched until I found the vendors that were the distributors and actually sold Gibson the parts. On these documents I found not only the vendors names but also the exact description of the parts and the specifications. Next I went to see if there were any blueprints but I did not have much luck there. Oh one other thing I forgot to mention one of the things I keep in my possession here at the Custom Shop are many original pickup, control assembly, and pickguard sample parts from as far back as the 40's including an original Double 12 wiring harness dated on March 1958 on the inventory/tracking tag. So once I found a vendor willing to listen to my request I sent him 5 original Bumblebee capacitors to run tests on with the specifications from my purchasing records. Once he ran the tests he informed me that to a degree there was a varied range of the voltage and capacitance. Two of the capacitors read exceptionally high indicating some kind of breakdown within the dielectric material (foil).

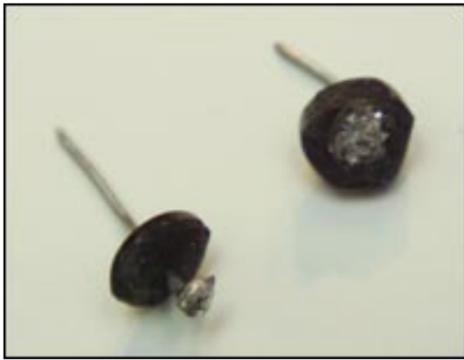
Original bumblebee leads
[Click for larger image](#)

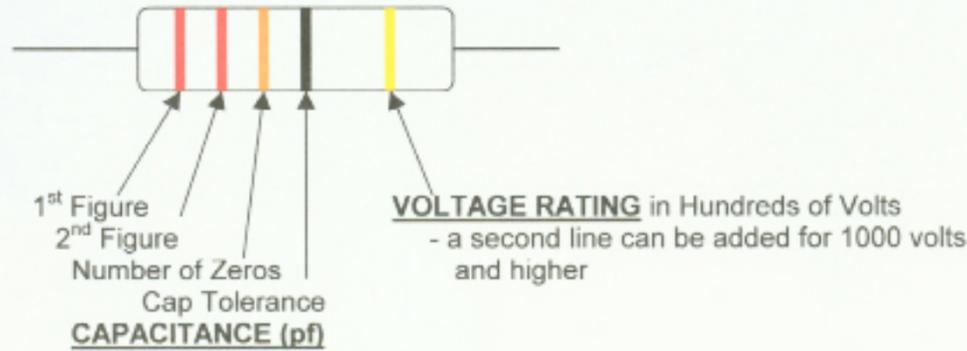
HOW TO READ CAPACITOR VALUES

Color	Figure	# of Zeros	Cap Tol.
Black	0		+/-20%
Brown	1	0	
Red	2	00	
Orange	3	000	+/-30%
Yellow	4	0000	+/-40%
Green	5	00000	+/-5%
Blue	6	000000	
Violet	7		
Gray	8		
White	9		+/-10%

Example (shown above): The PF26 we are supplying to you is a 22,000pf +/-20% @ 400 volts

Red, Red = 22 Orange = 000 Black = +/-20% **Capacitance** = 22,000 pf +/-20%
 Yellow = 4 (hundreds) **Voltage** = 400 vdc
